Ptolemy Dean, 'The Wren Wing at Easton
Neston: A Tenacious Survivor', *The Georgian
Group Journal*, Vol. XX, 2012, pp. 33-50

THE WREN WING AT EASTON NESTON: A TENACIOUS SURVIVOR

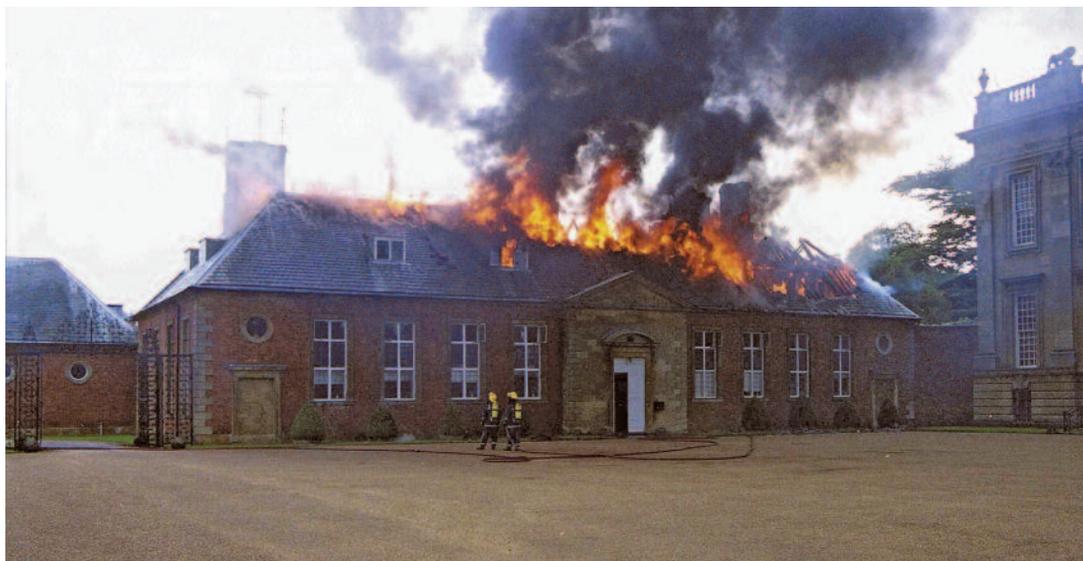
Fig. 1. The Wren wing ablaze.

As huge flames ripped through the roof of the so-called 'Wren Wing' at Easton Neston in 2002, with firemen left struggling to extinguish them with whatever water they could gather from a distant garden lake, few would have imagined that anything positive could possibly arise from such a tragedy (Fig. 1). Within three years, the present descendent of the ancestral owners of Easton Neston, Lord Hesketh, had put the whole of the estate on the market. The Wren Wing, shrouded in corrugated iron scaffolding and torn plastic sheeting, lay silent and unrepaired, offering a pathetic backdrop to a great three day long sale of the contents that took place in 2005.

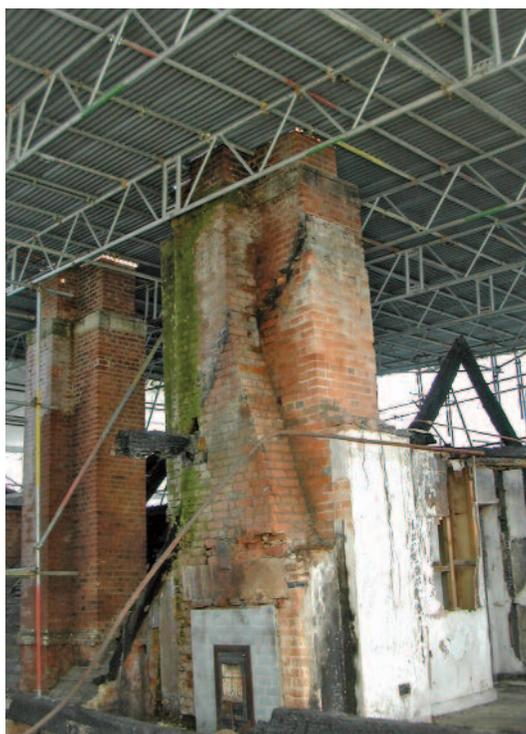
Fig. 3. Chimneystacks of the Wren wing after the fire.

But the loss of so much of the roof and second floor structure allowed the building and its noble brick chimney stacks to be seen and appreciated internally in a way that would never previously have been known (Fig. 3). Rather as Sir John Soane evidently marvelled at sight of the gutted shell of Wotton, a near contemporary house in date in Buckinghamshire that had burned out in the 1820's, so too it was possible to admire the verticality

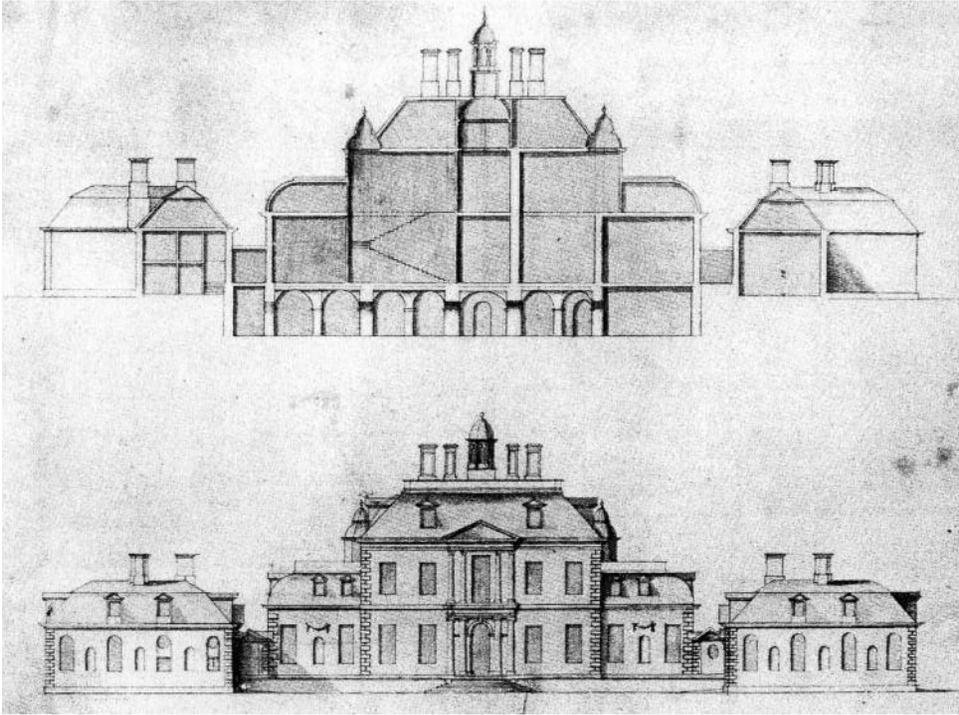
Fig. 4. A preliminary drawing by Wren for Easton Neston, c.1686, drawn by Hawksmoor.
All Souls College, Oxford.

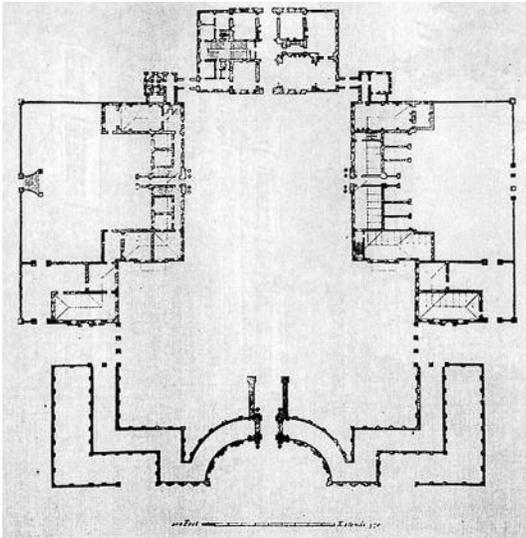
Fig. 5. Ground plan of Easton Neston, from *Vitruvius Britannicus*, I, pl. 98.

windows, the windows presumably being sized to allow them to achieve a proportion worthy of the main front forecourt of the house. The long passageways that extend behind these windows and along the south elevation appear likely to have always been a feature of the plan. This was confirmed by the archaeological survey commissioned by Lord Hesketh from ASC Ltd in 2005.⁶ The passageway running behind the south front is shown at ground level on the *Vitruvius Britannicus* plan of the building,⁷ which is the earliest historic plan of the building found to date (Fig. 5). A consequence of this passageway has been to leave the main rooms within the building facing north, probably a deliberate arrangement to reduce overlooking of the principal forecourt in front of Easton Neston House. The *Vitruvius Britannicus* plan also shows the previous connecting arrangement to the main house which

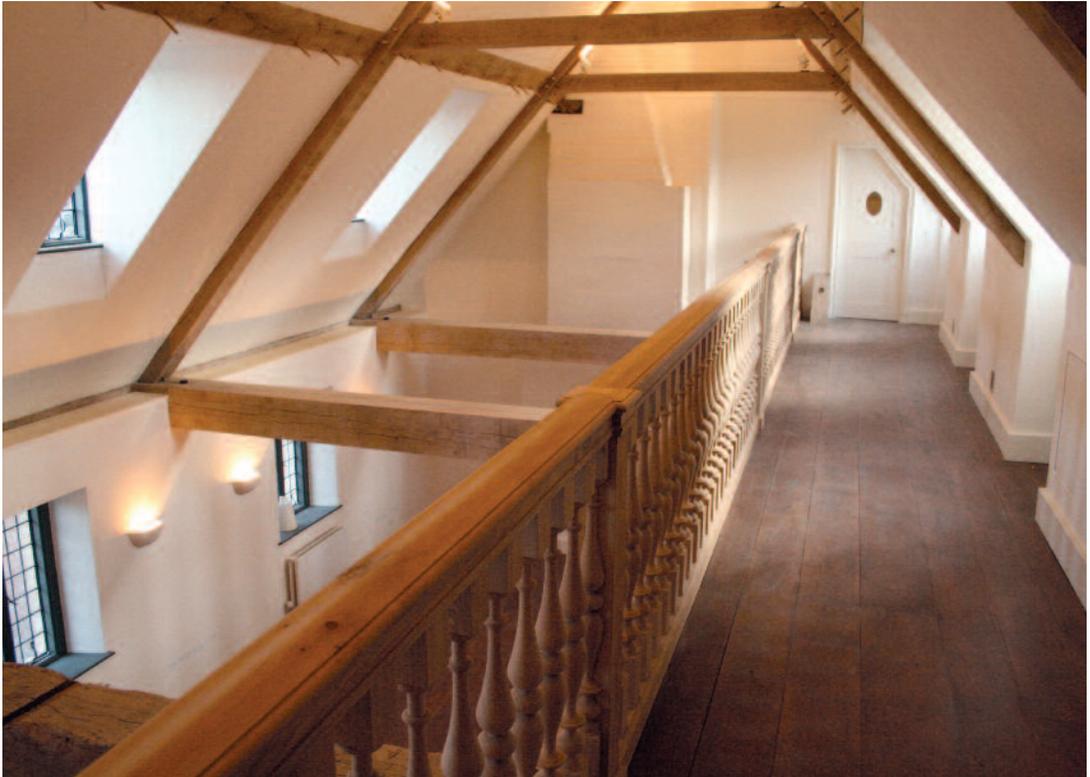
Fig. 7. The double-height gallery with exposed trusses.

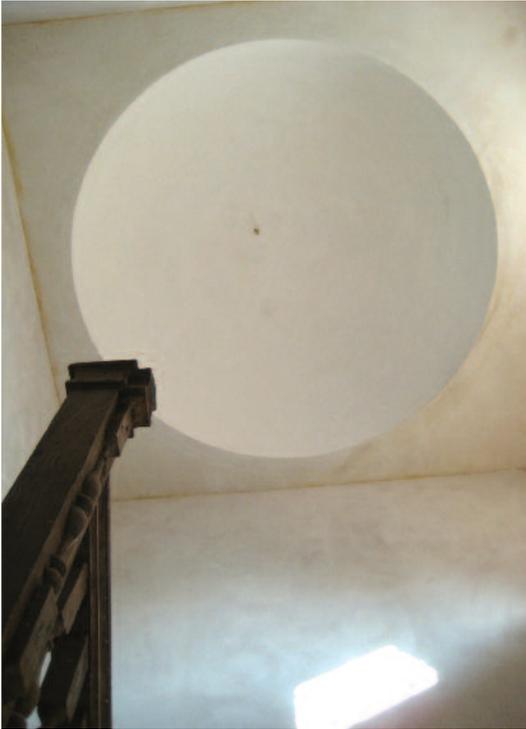
Fig. 8. The dome reinstated.

survived the fire. There is some question from the crispness of the structure that these may have been at least in part 'restored' in the widespread works that took place on the site in the 1920s. However, the shallow plaster dome over the west stair (Fig. 8), which was thought at one stage to have been a later addition, appeared from its integral construction with the roof trusses to have been original to the building. During the post-fire dismantling works, a handful of historic clay peg tiles were found on top of the dome structure. As this small void space was inaccessible and enclosed, these are likely to have been dislodged during the late-eighteenth or early nineteenth century re-roofing, when this range was re-roofed in Westmorland slate. Serious consideration was given to the reinstatement of clay peg tiles, but reinstatement of Westmorland slate, in keeping with the surrounding outbuildings, was ultimately preferred.

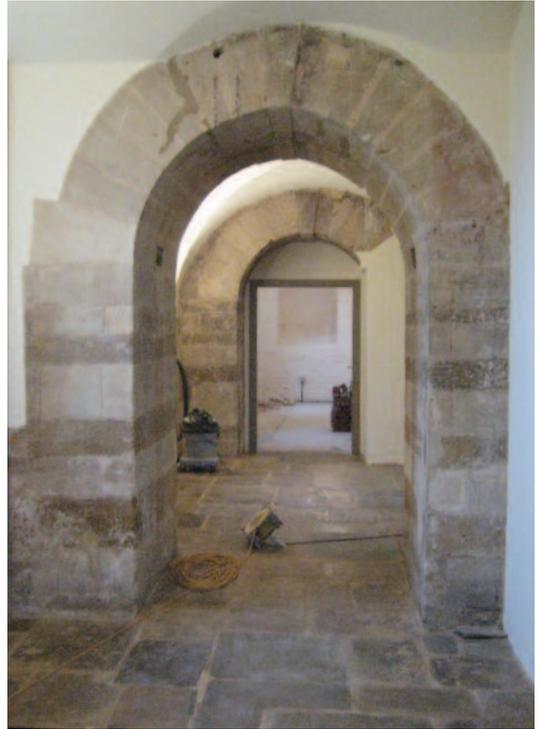
Fig. 9. Arches in the cellar of the main house.

Too recently constructed to be demolished, the Wren Wing and its opposite number the stables range would have presented a considerable architectural challenge to Hawksmoor when he was charged with the eventual design of the house. It is apparent that at least the basement of the house was begun before Hawksmoor's involvement. Its regular layout of brick and stone arches follows a conventional late-seventeenth century pattern of squared mini-vaults and piers. Where Hawksmoor changed the plan on the floor above in order to create the great cantilevered staircase, bold and deliberately alternating courses of banded harder ironstone and softer conventional limestone stonework were introduced. These archways have the same deeply recessed and monumental quality that is associated with his London churches (Fig. 9). The most remarkable basement insertion was to

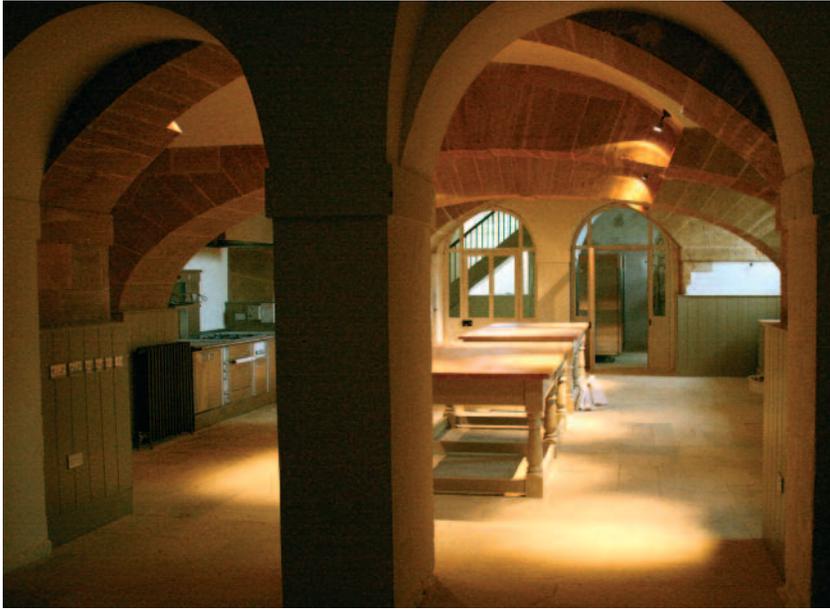
Fig. 10. Hawksmoor's kitchen in the basement of the main house.

The broad and beautifully gauged stone arches that supported the floor of the Great Hall at basement level formed Hawksmoor's new kitchen, replacing the kitchen originally provided in the Wren Wing. Hawksmoor's stonework has been recently stripped of paint and grease and re-exposed in both of these areas as a part of the recent restoration (Fig. 10).

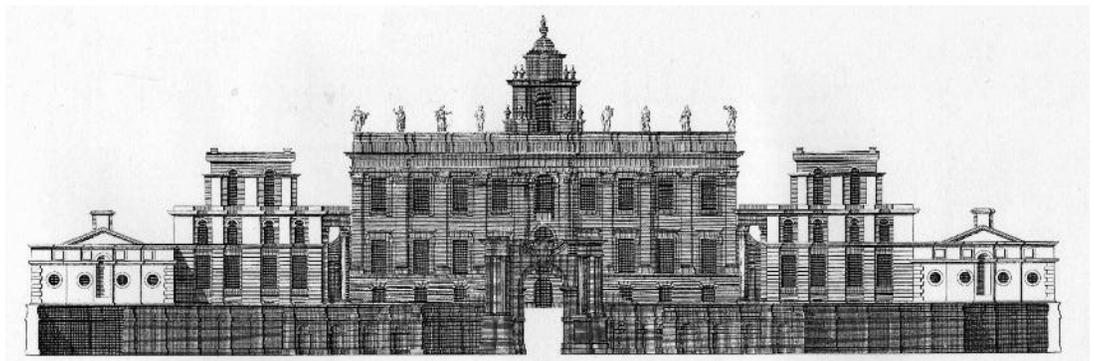
Fig. 11. Front elevation by Hawksmoor of Easton Neston, showing an unbuilt cupola, unbuilt wings and an unbuilt triumphal arch to the courtyard. *Vitruvius Britannicus*, I, pls. 99–100.

Externally the richly layered and compressed elevations of Easton Neston are undoubtedly a consequence of the enclosure offered by the inherited flanking service ranges. As so often with the very greatest architects, Hawksmoor seems at his best when challenged by a constricted site. The subtle but undeniably tangible tensions in the main elevations, particularly those facing east and west which are on several planes, remain as suppressed as if a mighty glacier were contained in a tight valley pass. While the site constriction caused by the Wren Wing and its opposite number have led to one of the most powerful country house elevations yet built, Hawksmoor must nevertheless have resented the constraints imposed by these existing buildings. Having failed in his bid to have them at least re-clad (Fig. 11), he famously described them to Lord Carlisle in 1731 as being ‘good for nothing’.¹⁰

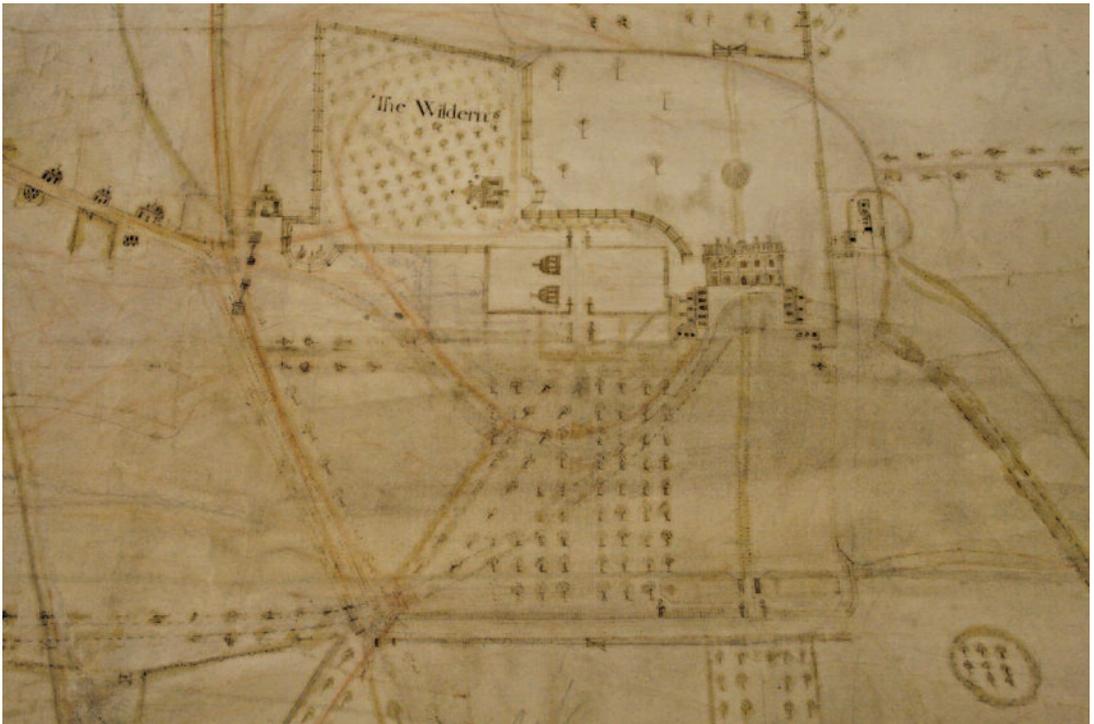
Fig. 12. The house and grounds from an estate survey of 1765. *Northamptonshire Record Office.*

It is clear from the sequence of historic maps held in the Northamptonshire County Records Office that the setting of the Wren Wing changed dramatically during the later eighteenth and early nineteenth centuries, as fashions in landscape planning evolved. It is likely that the present building only narrowly escaped demolition a hundred years or so later, and has been dramatically recast on at least two separate occasions prior to this most recent campaign of works. The first known survey of 1765 (Fig. 12), from the Northamptonshire Record Office, shows the present Wren Wing (drawn diagrammatically) flanking the main block of the house, with its symmetrically placed stables block facing it across the front forecourt. It also shows the fine formal avenues of trees radiating from the house and the formal walled gardens which still survive. This plan no doubt records the arrangement that

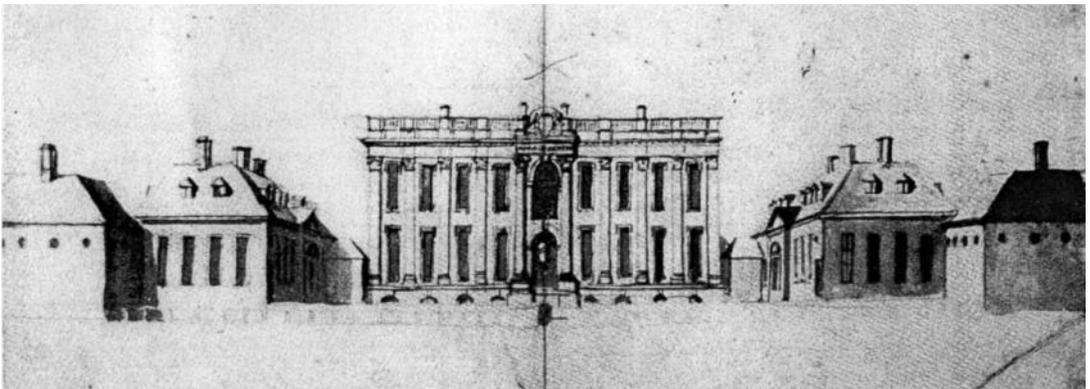
Fig. 13. ‘Prospect of the Lord Lempsters house at Easton taken to the West’, by Peter Tillemans, 1719. *British Library, Add MS 32467.*

was drawn by Tillemans in 1719, which remains our best visual record of Easton Neston soon after completion¹¹ (Fig. 13). The catalyst for the first significant change after completion appears to have been the creation of a new turnpike road in 1795, replacing the old Northampton to Towcester road which had previously run through Hulcote Village and Easton Neston. The 1795 road – which survives in part as the present A43 route into Towcester – was located significantly west of the house, and allowed its whole setting to be reconsidered and re-landscaped. Clearly pencilled in red over the 1765 plan are the new alignments of the Turnpike Road and some suggested driveway changes, all following more informal and picturesque alignments. A survey plan of 1806 (Fig. 14) illustrates how dramatic the remodelling would prove to be. The old stable block, the twin of the present Wren Wing, was completely removed and its site cleared. It was replaced by the present stable courtyard located well to the north of the Wren Wing and west of the walled garden, one of whose entrances had been carefully placed on the central axis of the Wren Wing itself, perhaps by Hawksmoor. The listing description gives the name of the architect for the new stables as John Raffield, a relatively little known early-nineteenth century architect.¹² No specific date of construction is offered. A discrepancy between the

- 18 Howard Colvin in his article ‘Easton Neston Reconsidered’ (*Country Life*, 15 October 1970, pp. 969–70) cites the account book of John Groves, a well known London Master Carpenter who recorded amongst other works at Easton Neston: ‘luthern windows with caps and pediments’. As the main house had not yet been started, Colvin argues that this description must predate 1692 and must therefore relate to the two service ranges. Whilst alternating cusps and dormers were typical of the period, Tillemans’s sketch of 1719 (Fig. 13) appears to show only pediments throughout.

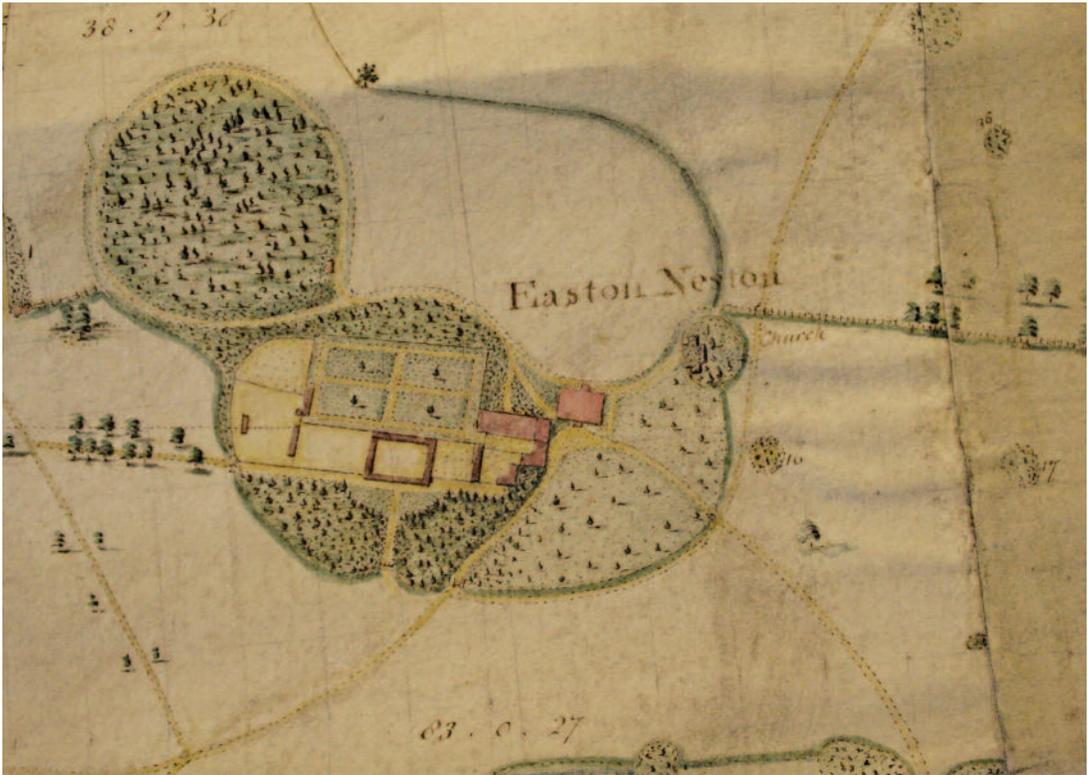
Fig. 14. Plan of the house and grounds from an estate survey of 1806. *Northamptonshire Record Office*.

estate maps of 1806 and 1849 in the placing of the new stable courtyard possibly holds a clue to this. The 1806 plans show the building placed on axis with a drive to the west and not on axis with the walled garden. This may have been as the building was planned at that time, rather than as built. Comparison with an 1849 plan confirms that the final and present placing of the new stables building was changed to address the central axis of the walled garden, rather than the existing estate driveway, which was adjusted to suit the new location.

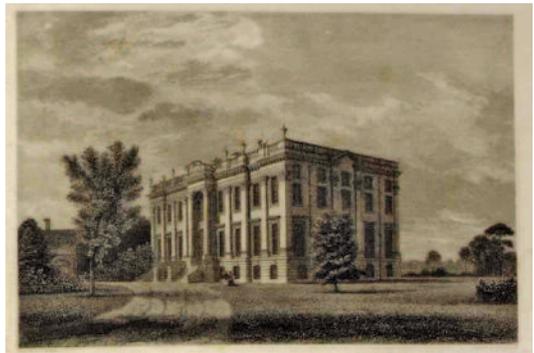
Fig. 15. Easton Neston in the early nineteenth century. Engraving by W.S. Williamson after J.C. Buckler.

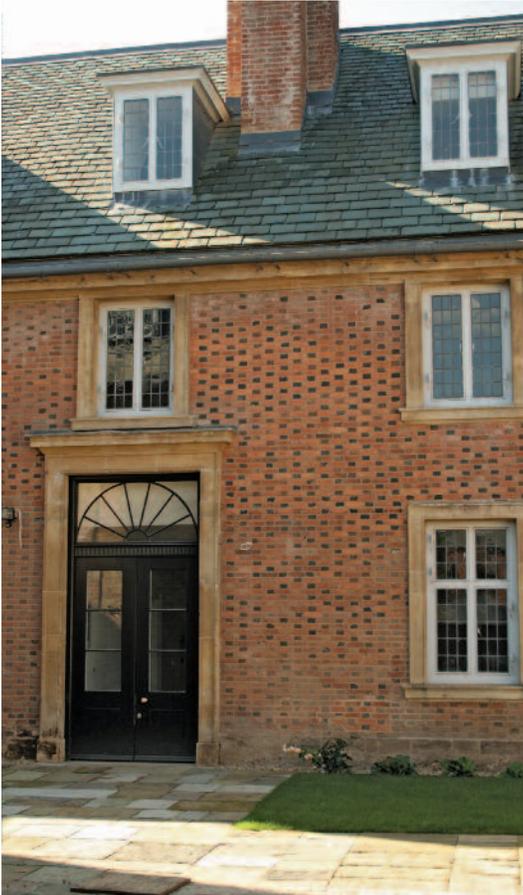
Fig. 16. New entrance to the Wren wing.

It is now apparent that the concealing of the south front of the Wren Wing meant that the building needed a new entrance from the back. The building was therefore ‘turned around’ and remodelled so that its north side, facing the service yard, could become its main entrance, leaving the southern side facing the house undisturbed by comings and goings. This is supported by evidence of significant, but to date undocumented, early-nineteenth century works to the north side. With a regular placing of windows and cheerfully pronounced red and blue header brickwork, this façade is quite different from the mellow brickwork of the south side, and very similar

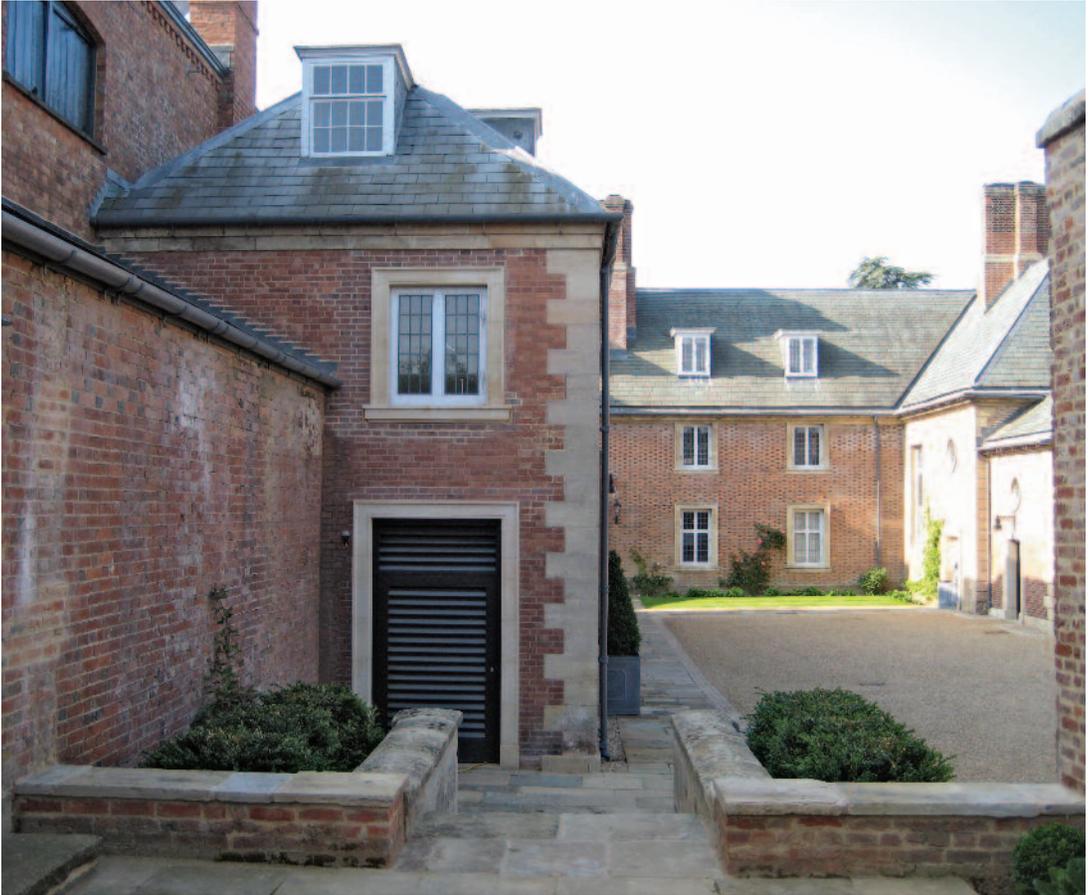
Fig. 17. The entrance to the Real Tennis Court, intruding on the seventeenth-century north-south axis.

extended outwards into the Wren Wing courtyard, with a first floor library over lower floor ablutions and changing rooms. This addition was carried out in a sympathetic ‘Wren Wing Style’ but regrettably using the visually inferior Easton Neston Estate brick (which more resembles the anaemic washed-out colour of common Bedfordshire stocks than the warm red tones used on the original buildings). Even more unfortunate was the form of this addition, which intruded on the historic seventeenth-century axis from the north front of the Wren Wing to the walled garden (Fig. 17). With the setting of the north side of the Wren Wing compromised once more, there

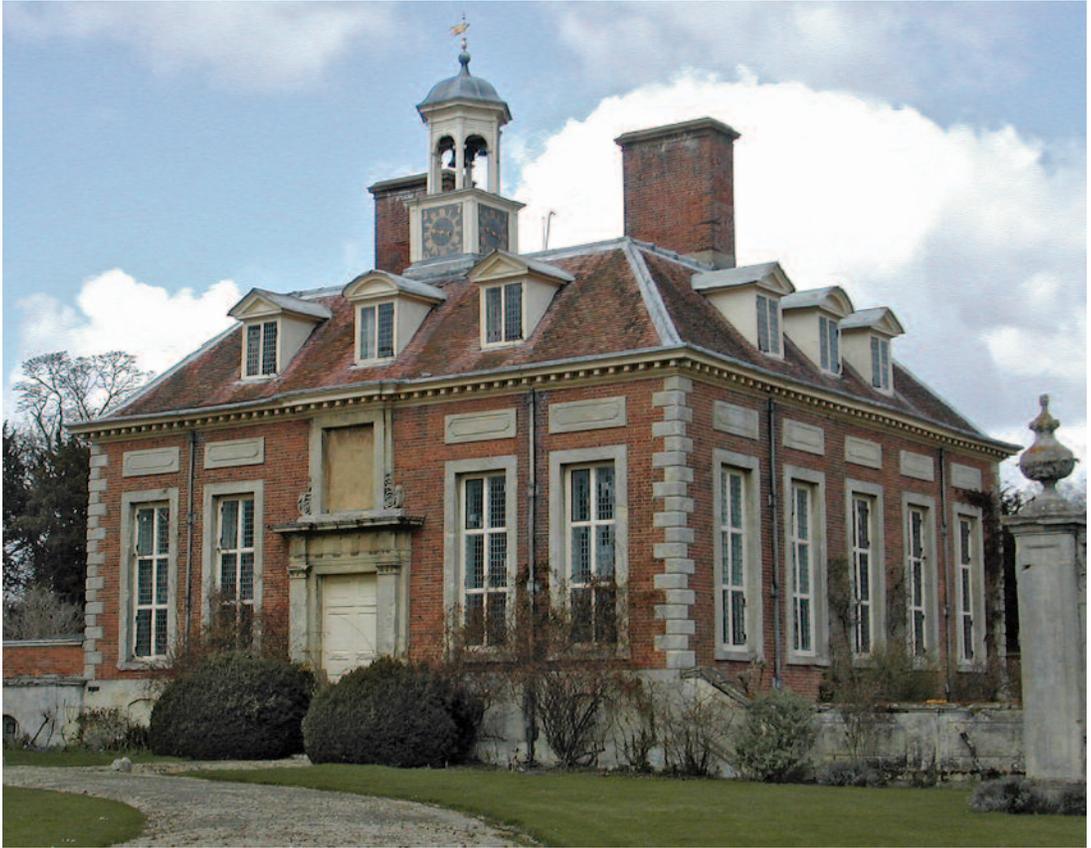
Fig. 18. The flanking kitchen wing to Wotton House, Buckinghamshire.

provided at Easton Neston. These Wotton dormers survive with pediments and their leaded metal casement windows with small panes of glass (Fig. 18). A pattern of slightly smaller proportioned leaded lights appear to survive at Easton Neston at ground floor level on the north side of what is now the Boiler House.

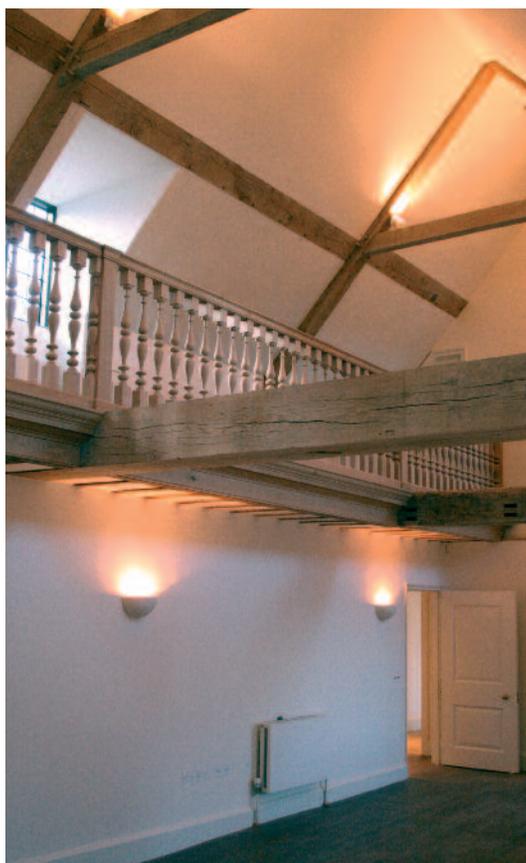
Fig. 19. New design studio.

Where changes internally were proposed, they sought, as far as possible or practical, to return the architectural layout of the Wren Wing to that originally constructed. The absence of drawings has made this difficult to verify, although the plan published in *Vitruvius Britannicus* was helpful, combined with the evidence found in the fabric on site. The celebrated wooden model of Easton Neston (now in the RIBA drawings collection) survives, but does not include the Wren Wing. The gutting of the eastern section of the building allowed for a section of the second floor to be left open, thereby allowing the light from the large south facing windows to flood over a new gallery to light what is now a design studio (Fig. 19). This new double-height space, with

the prominent undulations of its flanking chimney stacks, seeks to capture the sense of space and character of this building once its previously cellular structure was opened up by the fire. The gallery edge was reinstated in oak, but follow the original Wren pattern that had also been faithfully copied in the 1920s work.

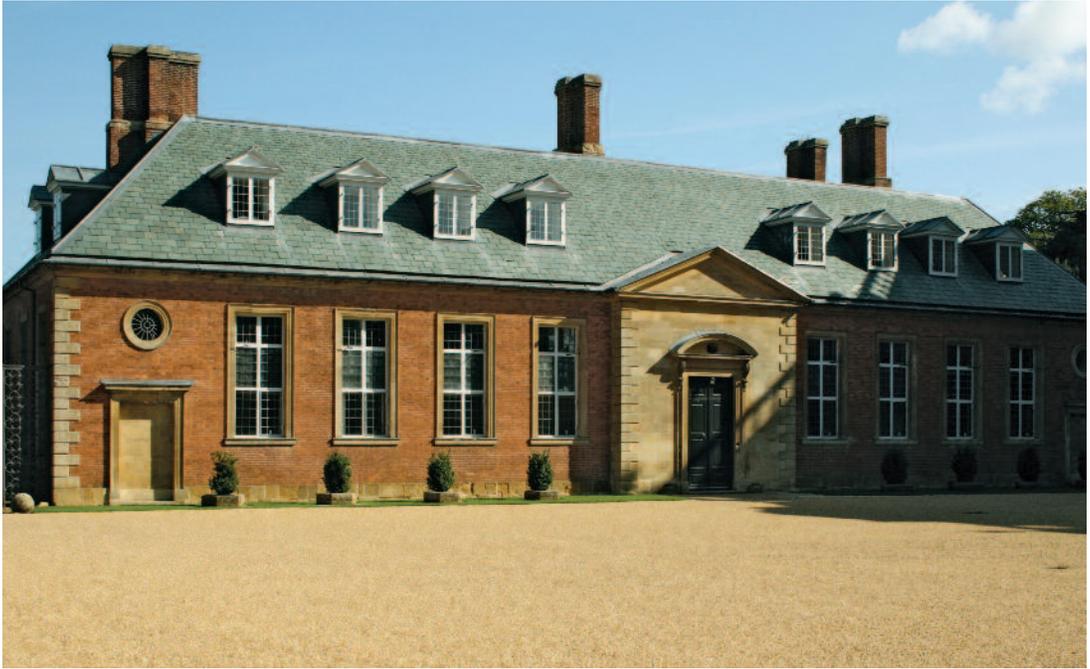
Fig. 20. The south elevation of the Wren wing in 2011.

A final key change in planning was the creation of a new second-floor link from the Wren Wing into the nineteenth-century Real Tennis Court building which was immediately adjacent. This passed via a former dormer window, and deposits users into the Real Tennis Court itself, a large open building now used for clothing distribution and packing. A metal gallery structure has been introduced that is dismountable and reversible should real tennis ever be sought here again. For now, this installation, deemed as ‘furniture’ for consent purposes, allows this building and the adjacent Wren Wing to face a bright and sustainable future at the heart of a new owner’s ambitions for Easton Neston.²⁰ (Fig. 20)
