# HISTORIC DETAILS: RAINWATER GOODS

In the seventh in his series on Georgian architectural furnishings, **Charles Brooking**, looks at the design and development of Georgian rainwater goods

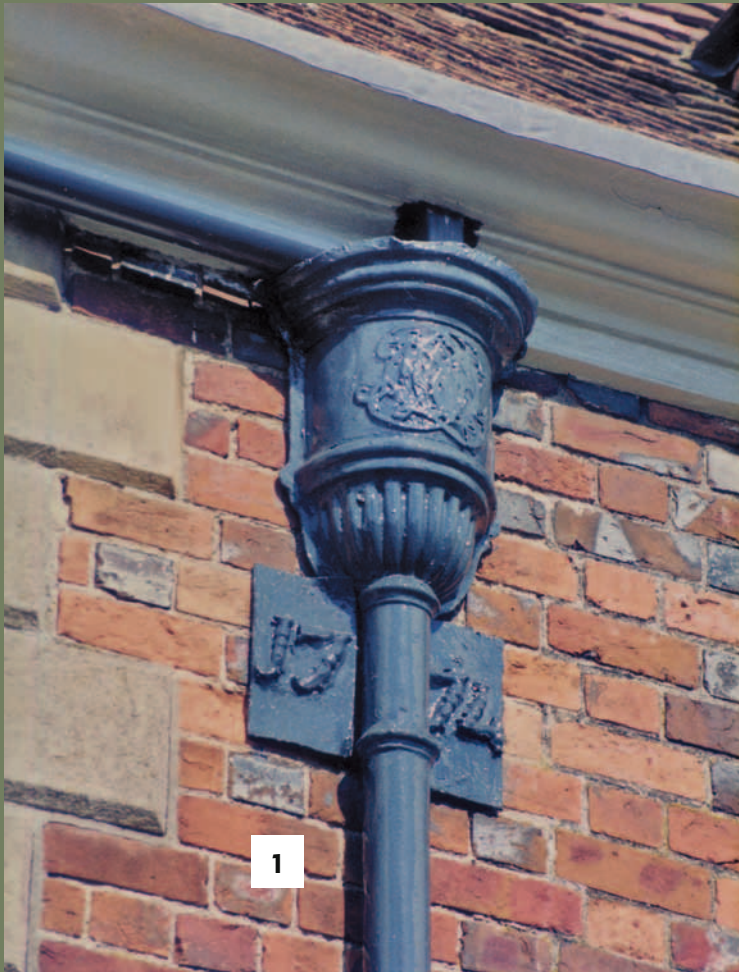
Fine late 18th century lead rainwater head with downpipe, with owner's cypher and elaborate cast-lead date numerals.

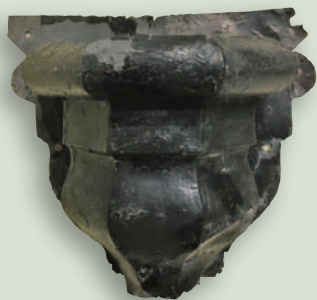
Zinc rainwater head, c.1820s–30s. This is constructed of zinc sheet sections soldered together.

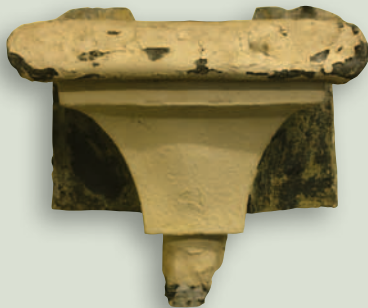
Simple lead rainwater head, c.1810–28, from Woodhill Manor, Shamley Green, Surrey.

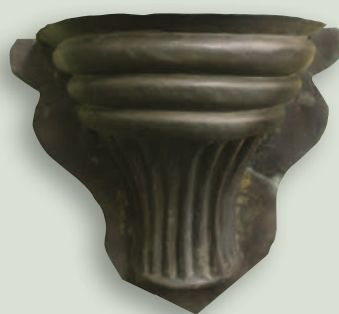
Sheet copper rainwater head, late 18th/early 19th century. This design was almost certainly worked around a wooden former-block, as with lead varieties.

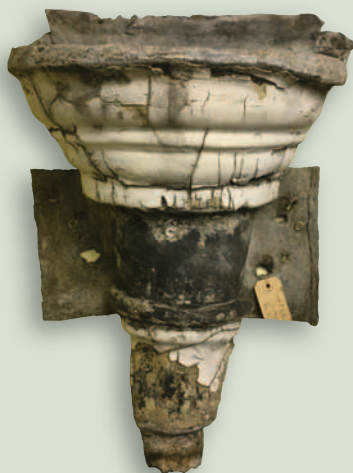
Late 18th century tapering semi-circular design, c.1780–89. The lead flaps that originally covered the wrought-iron fixings have been lost.

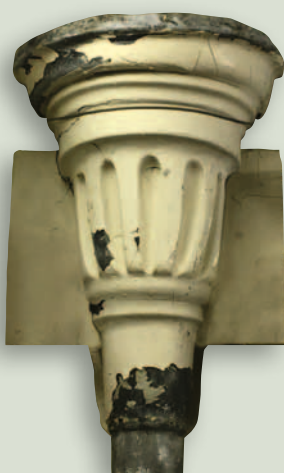
Fine late 18th century widely used rainwater head pattern. Typical of designs that have been dressed over a wooden former-block.

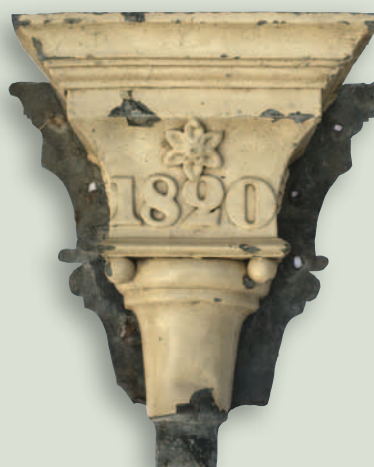
Lead rainwater head. Note cast lead floret and spheres, the numerals were cut from lead sheet.

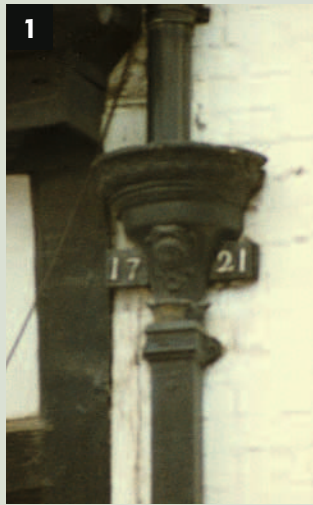
**1** Lead rainwater head with central cast-lead decoration and later cast-iron rectangular downpipe.

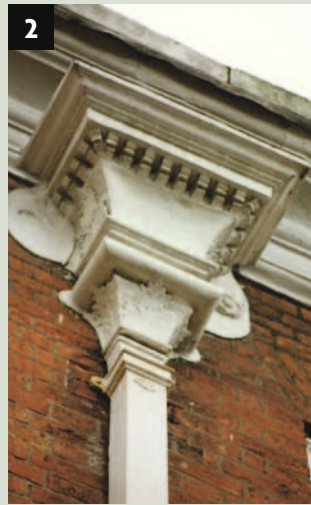
**2** High-quality lead rainwater head with cast-lead naturalistic decoration, and dentil cornice, the front panel appears to have been lost, the downpipe being modern.

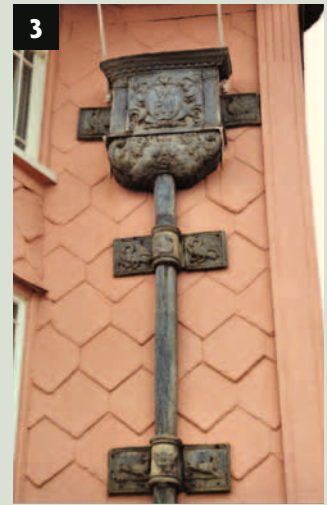
**3** Highly ornamental head, pipe-brackets and downpipe of 1722, probably entirely of cast lead. Note fluted pilasters, dentil cornice, and depiction of birds on pipe-brackets and fixing ears. Re-sited to a house on the promenade at Lyme Regis, Dorset.

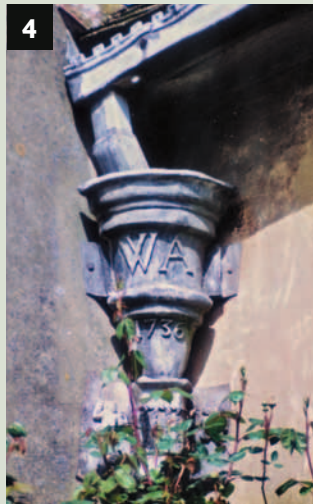
**4** Corner lead rainwater head with the owner's initials. The lead guttering is possibly an early Victorian addition. The rainwater head has been re-fixed at some time with later exposed fittings.

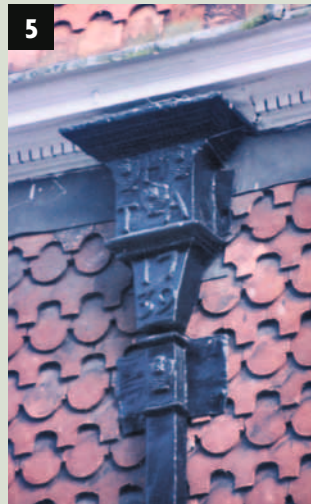
**5** Lead example retaining its original rectangular section downpipe, with cast-lead ornaments and initials.

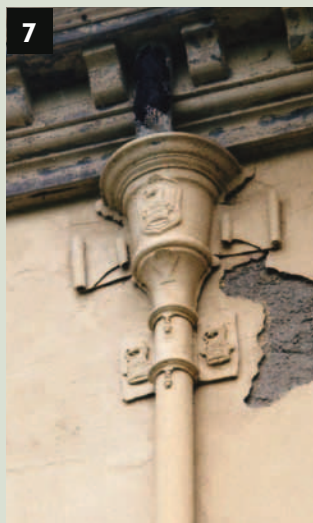
**7** Fine mid-18th century example with family crests on rainwater head and downpipe bracket, and fixing 'ears' with scrolled sections covering the fixings.

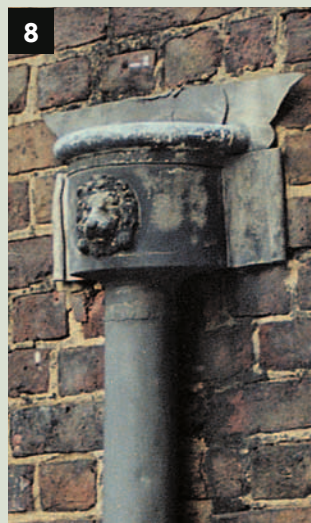
**8** Restrained lead rainwater head with 'lion's mask', c.1813. From the rear elevation of The Sir John Soane's Museum, London. A typically restrained Regency design.

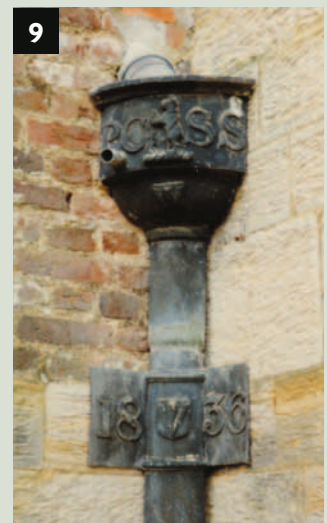
**9** Corner lead rainwater head with a crest and initials, 1836, from Penshurst Place, Kent. Despite the availability of cast-iron, lead continued to be employed in high-status work.

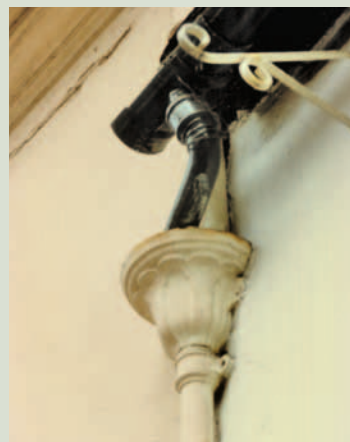
A fine example of an ornamental semi-circular tapering cast-iron rainwater head, c.1820–50.

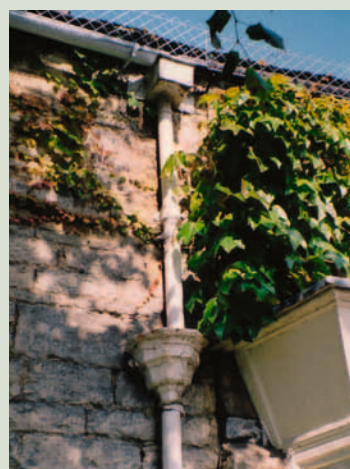
A combination of lead and cast-iron rainwater goods, c.1820–35. Note the simple lead box design (top) with rolled moulding to the upper edge. The cast-iron rainwater head (below) is a faceted design widely used from the early 19th century until the early 20th century.
